Operating Experience Weekly Summary 97-46

November 7 through November 13, 1997

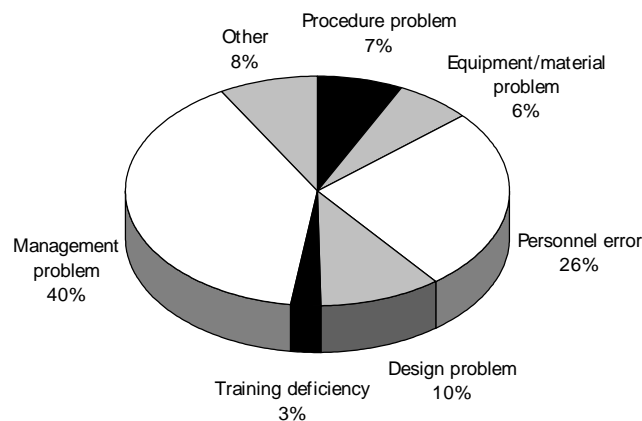
OEAF engineers searched the ORPS database from 1994 to present for events reported across the DOE complex under the nature of occurrence “near-miss” and found 539 occurrences. Figure 1-1 shows that facility managers reported management problems as the root cause for 40 percent of the occurrences. They also reported that personnel error accounted for 26 percent of the violations. Further review shows that 29 percent of the management problems were reported as inadequate administrative control, and inattention to detail accounted for 46 percent of the personnel errors.

Figure 1-1. Distribution of Root Causes for All Near-Miss Occurrences¹

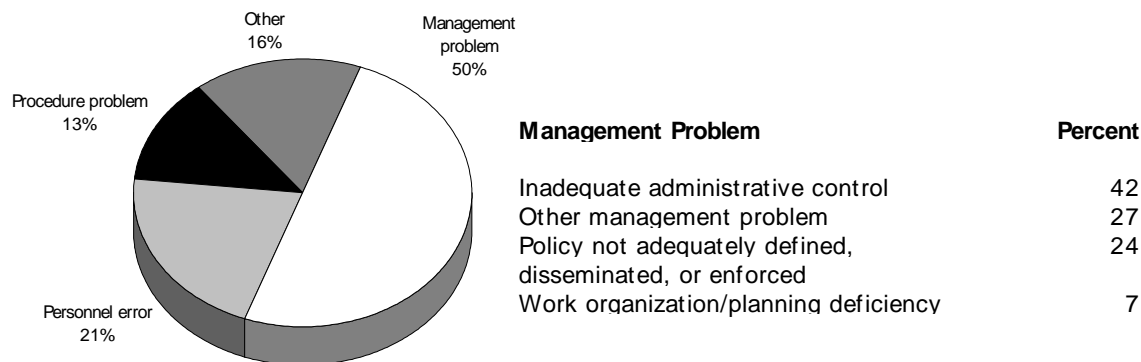
OEAF engineers searched the ORPS database from 1990 to present for events involving nuclear material inventory storage violations and found 323 occurrences. Figure 6-1 shows the root causes for these events. A review of these occurrences shows that DOE facility managers reported 50 percent of the root causes as management problems, with 42 percent attributed to inadequate administrative control.

Figure 6-1. Root Causes for Nuclear Material Inventory Storage Violations¹
